Nondestructive Testing of Ship Hulls Made of Composite Materials Using Acoustic Methods

M. E. Frantsev

Neptun—Sudomontazh, Dolgoprudnii, Moscow Oblast, Russia

Abstract—A technique for the nondestructive testing of ship hulls that are made of composite materials in the process of their operation is considered. The study was performed using the impedance method and the free-vibration method taking the peculiarities of the test-object design into account. The results are presented.

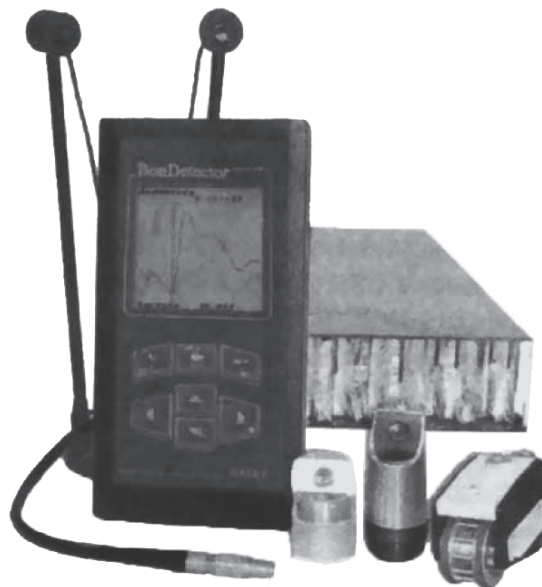
Fig. 3. A portable ДАМИ-С flaw detector.

Since ship hulls that are made from composite materials have guaranteed geometric sizes only over one (the outer) surface, the application of echo methods that are based on the signal reflection at the second surface can lead (without special studies) to inadequate interpretation of the test results and the decisions taken based on them will be erroneous. In addition, echo methods are difficult to implement if a test object has a large number of curvilinear surfaces (the hull of a high-speed ship is such an object). The peculiarity of the echo methods is the impossibility of performing testing at depths of 3–5 mm from a surface (with the total thickness of the hull shell for ships of the analyzed type are not greater than 5–8 mm in some places). Therefore, the impedance method and the local free-vibration method (see table, [5]) were accepted as the base methods for nondestructive testing of the flaws in multilayer ship hull structures that are made of composite materials. The ДАМИ-С flaw detector for composite materials is used as a device that performs both methods (Fig. 3) [3, 4].
